# Inspection Report

[REDACTED]  
Evansville In 47715

**Natchez Corp**

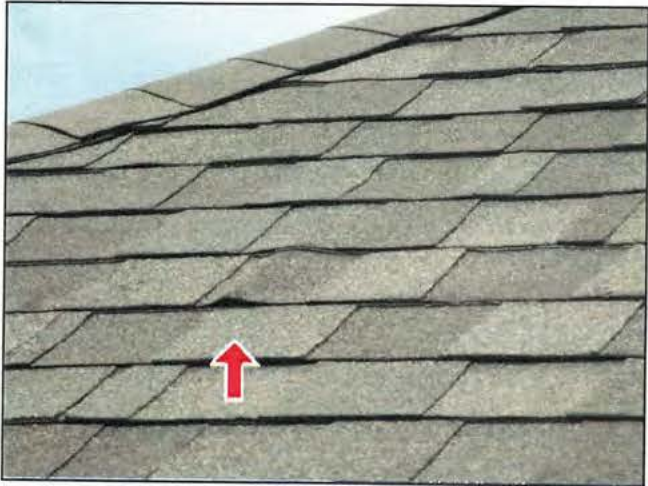
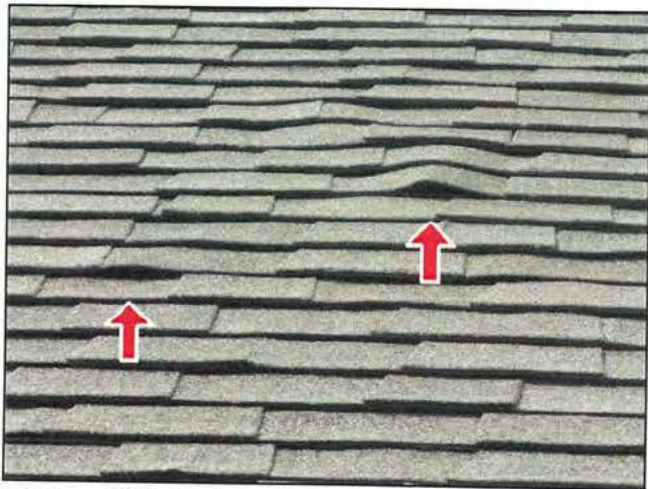
1.0 (3) The roof covering has raised shingles at areas of home. This does not appear adequate. It should be properly repaired or replaced. A qualified contractor should inspect and as needed.

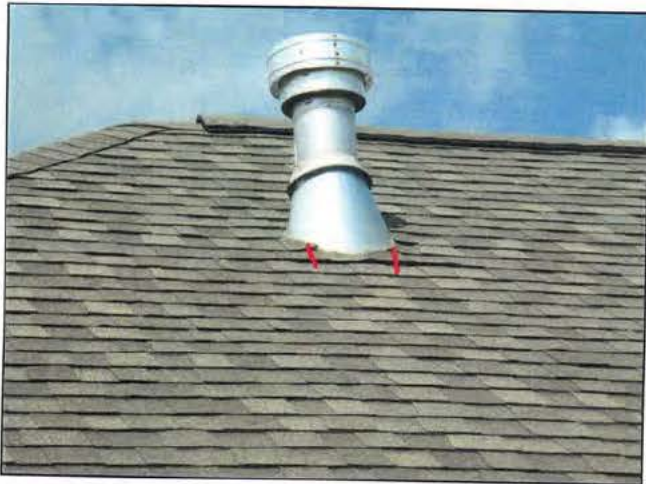
1.1 Item 1(Picture)

1.1 The flue pipe flashing needs roofing cut to allow water flow or rain water to get out. The . . A qualified roofing contractor should inspect further and correct as needed.

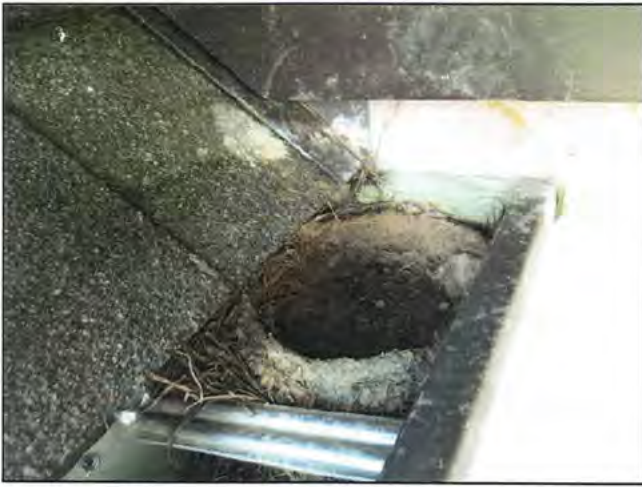
1.3 Item 1(Picture)

1.3 (5) The gutter has a birds nest at the front (left of main entry). . A qualified person should repair or as needed.

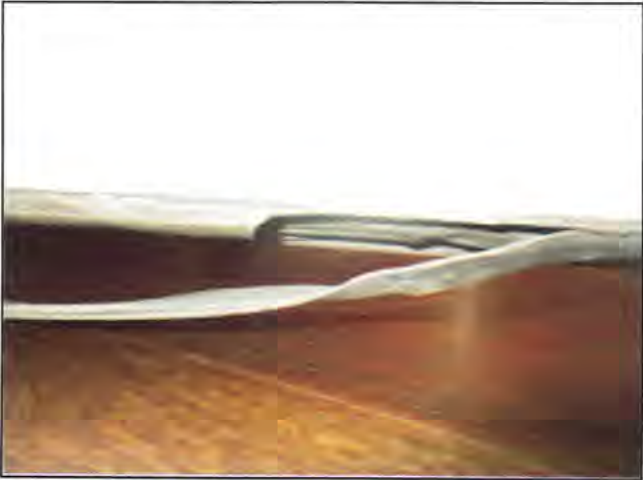
2.1 Item 1(Picture)

2.1 (1) The main entry door from house to garage is damaged at weather-stripping. . .

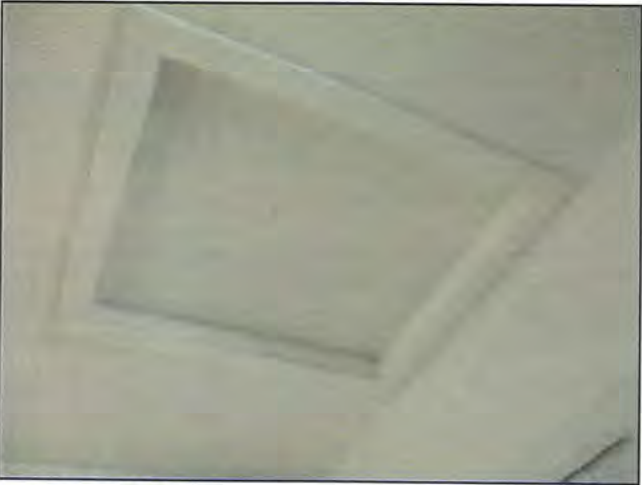
3.0 Item 1(Picture)

3.0 The wood attic accesses on the garage ceiling don't meet fire code. . .

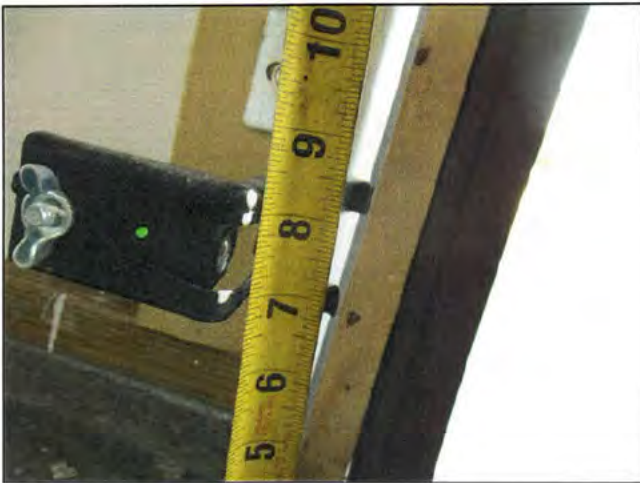
3.5 Item 1(Picture)

3.5 (2) The garage doors at the front of home has electronic sensors located higher than six inches off floor which may not be installed according to manufacturers specification. . I recommend a qualified garage door repairman correct as needed.

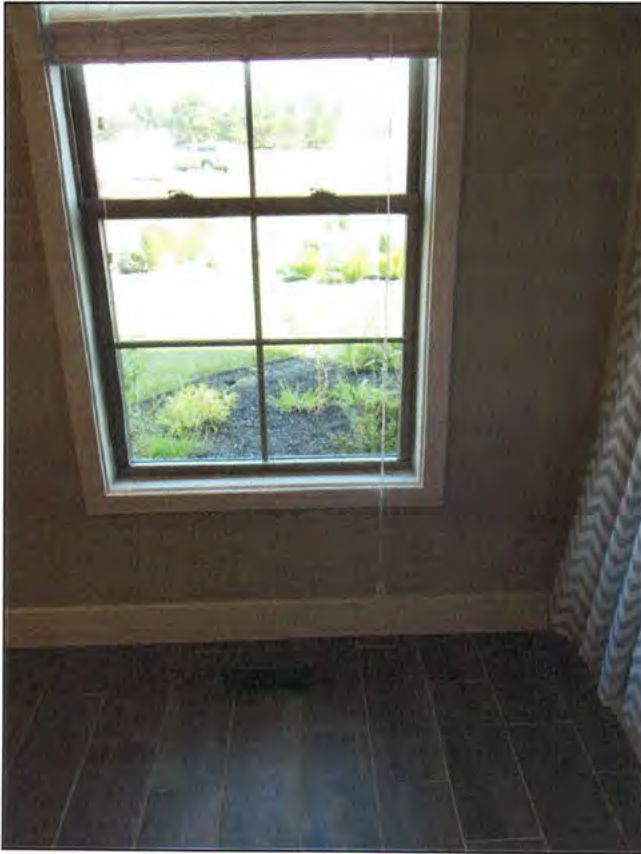
4.6 Item 1(Picture)

**4.6** One window not tempered safety glass at the Guest bath. slip or fall out of tub/shower not safety glass. A qualified contractor should inspect and repair as needed.

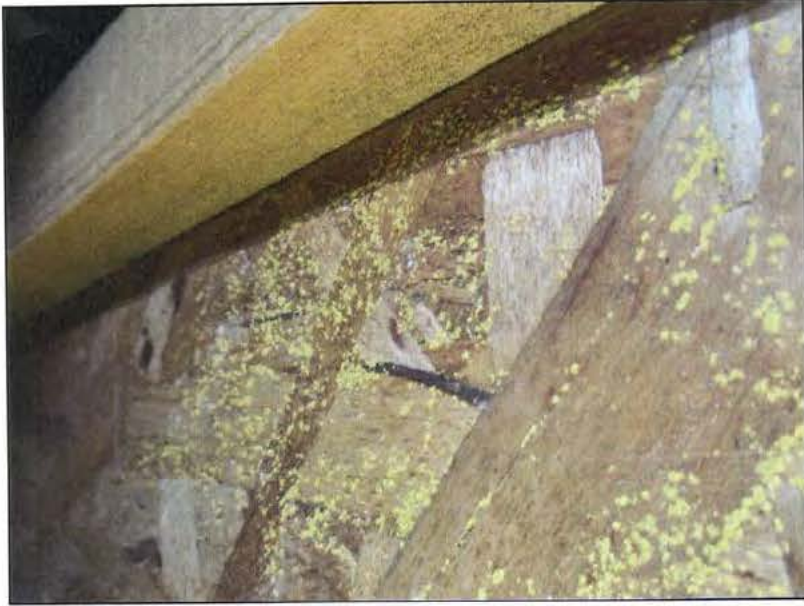
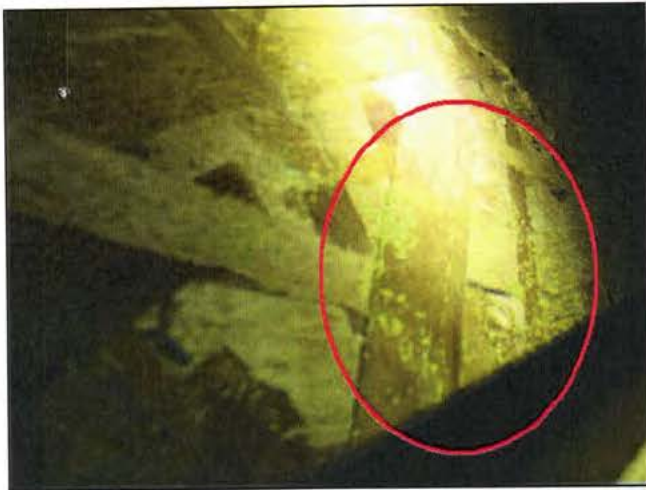
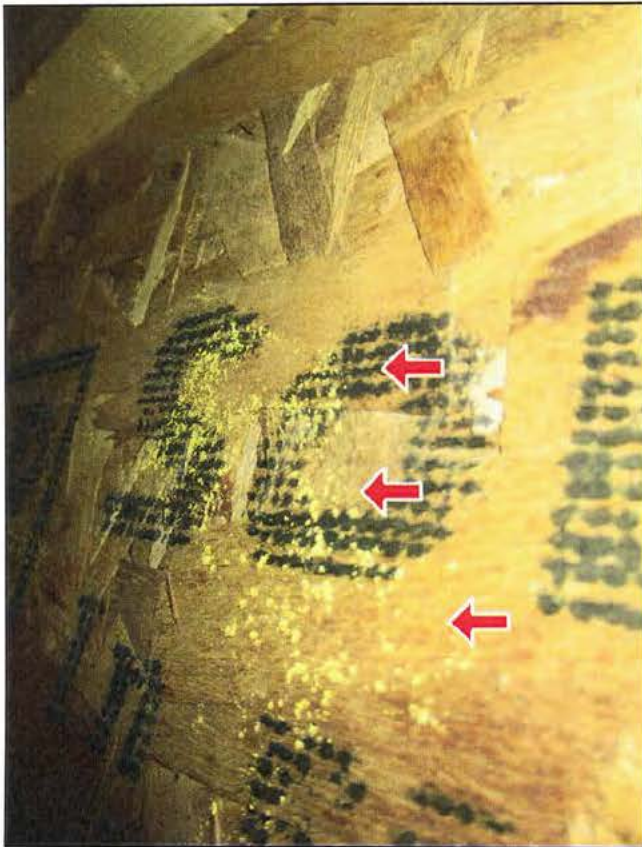
**5.0** (1) Signs of fungi growth is present on the floor system in crawlspace in several areas. We did not inspect, test or determine if this growth is or is not a health hazard. The underlying cause is moisture. I recommend you contact a mold inspector or expert for investigation or correction if needed.

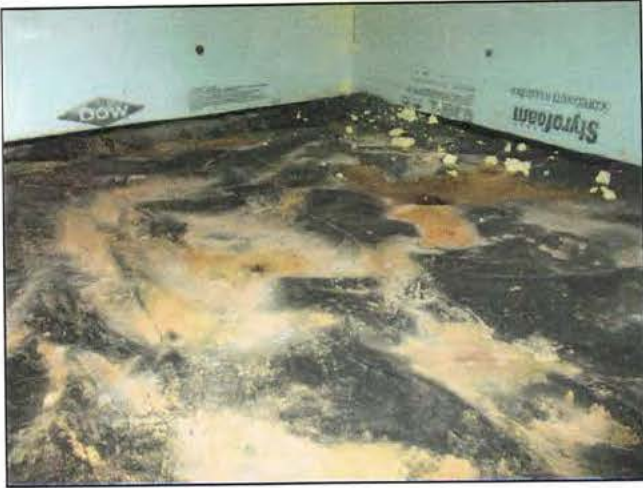
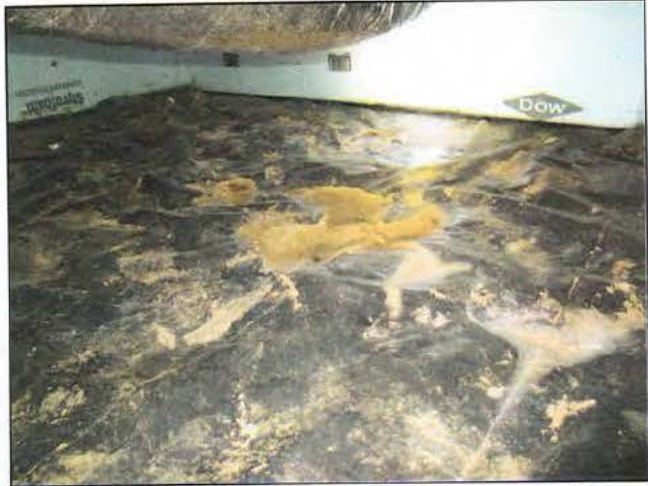
**5.0 (2)** Visible signs of water intrusion in the crawlspace are present from water stains on on plastic vapor barrier. I am unable to determine the extent of intrusion or how often it occurs. I recommend further investigation or correction by a qualified licensed contractor or water infiltration specialist.

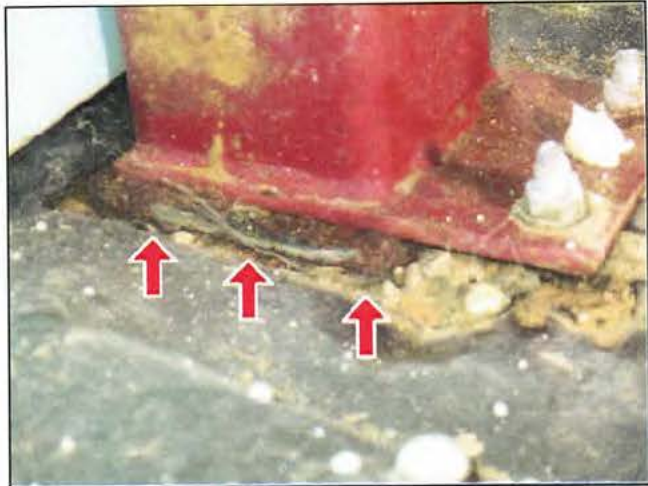
**5.2** The support posts are deteriorated at the bottom of the posts in the crawlspace. the shims are rusting to fast either the posts are rusting lack of no separation from concrete or humidity.. A qualified licensed general contractor should inspect further and repair as needed.

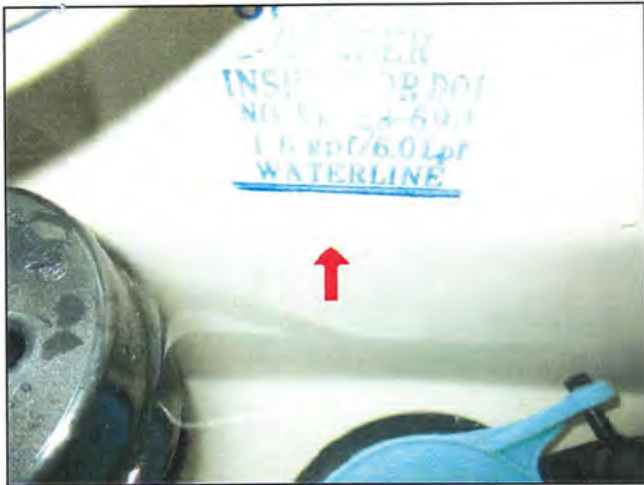
6.0 Item 1(Picture)

**6.0 (1)** The toilet fill line needs to be adjusted to ensure proper flushing at the hall bath. . A qualified licensed plumber should repair or correct as needed.

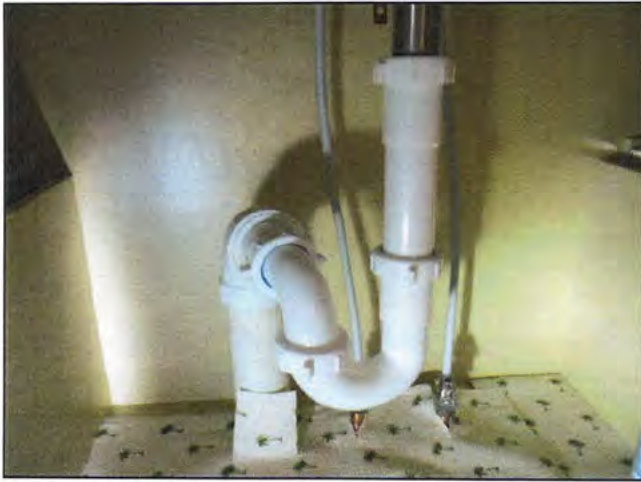
6.0 Item 2(Picture)

**6.0 (2)** The plumbing waste line is a S trap and needs upgrade to a P trap with an auto-vent at the Hall Bath sink and laundry room. This is not considered up to today's standard. A qualified licensed plumber should repair or correct as needed.

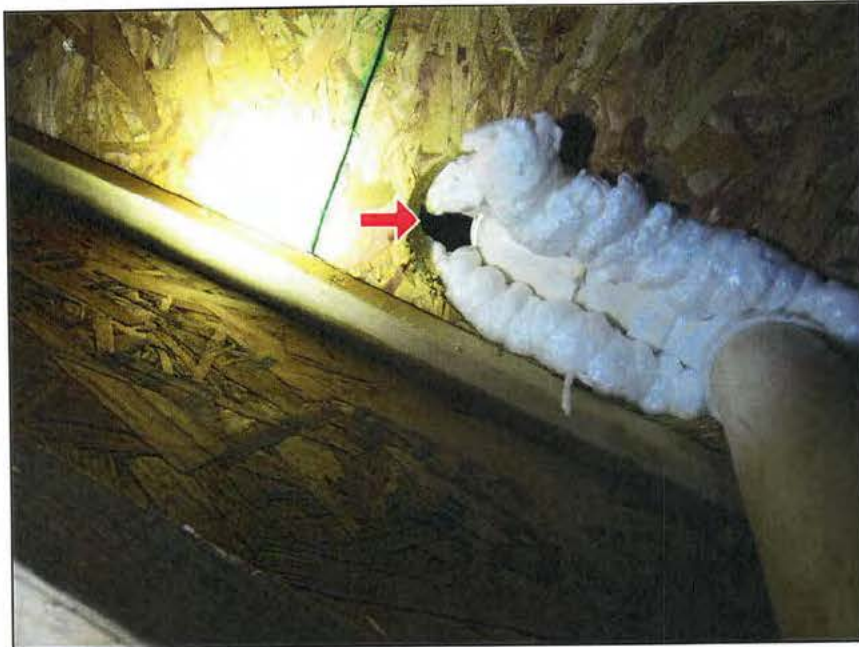
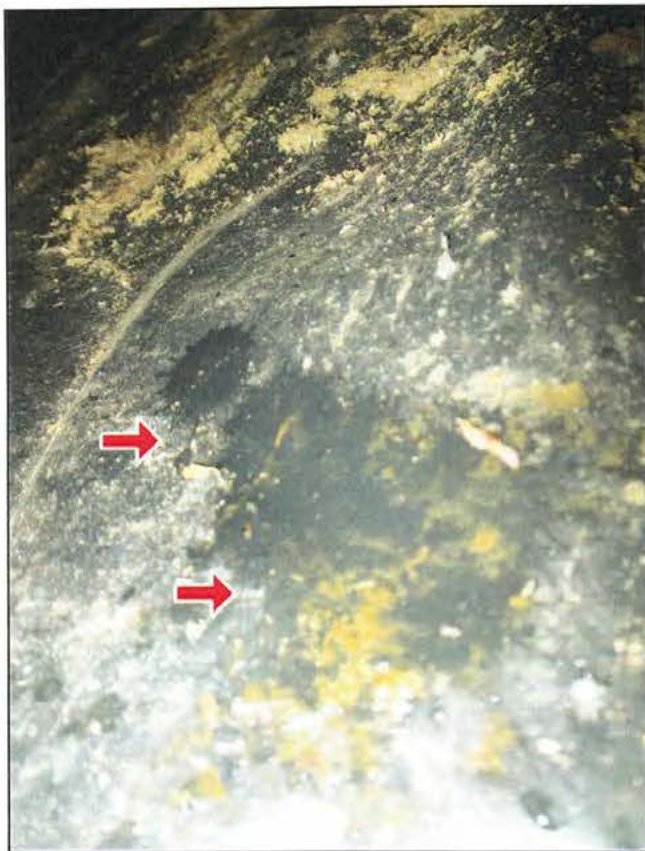
**6.0 (3)** The plumbing waste line not pitched correctly under the hall bath. . I recommend a licensed plumber inspect further and repair as necessary.

6.0 (4) The tub drain leaks under the hall bath. . A qualified licensed plumber should repair or correct as needed.

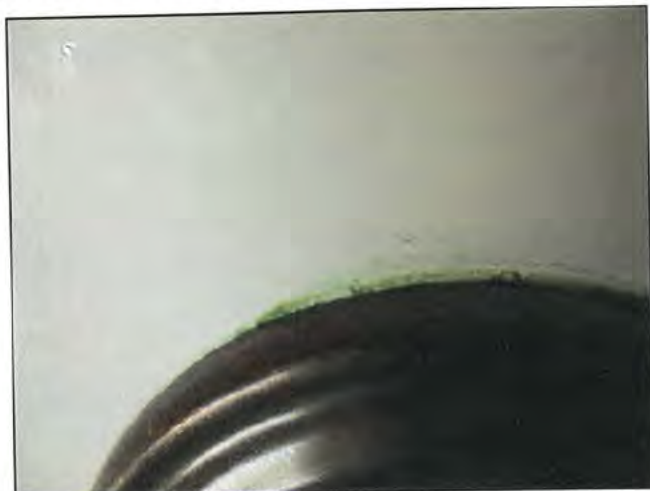
**6.1 (1)** The tub faucets leaked at one time but not time of inspection at the master bath tub. This is for your information..

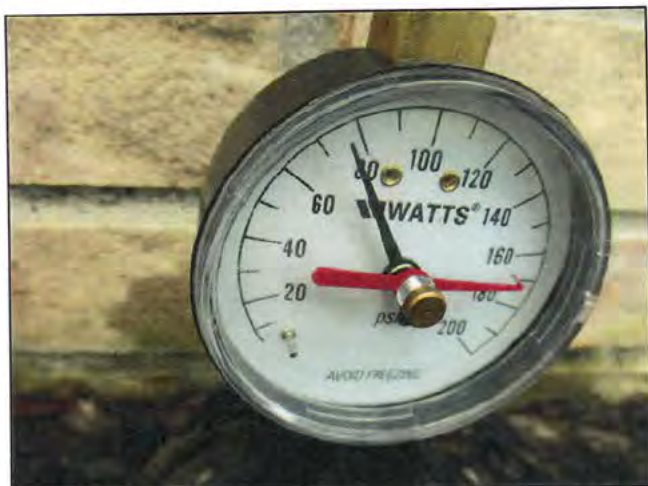
6.1 Item 3(Picture)

**6.1 (2)** The cold supply line that distributes water threw out the home has high water pressure needs regulator that allows for thermal expansion to keep pressure at 60 psi . . A qualified licensed plumber should repair or correct as needed.

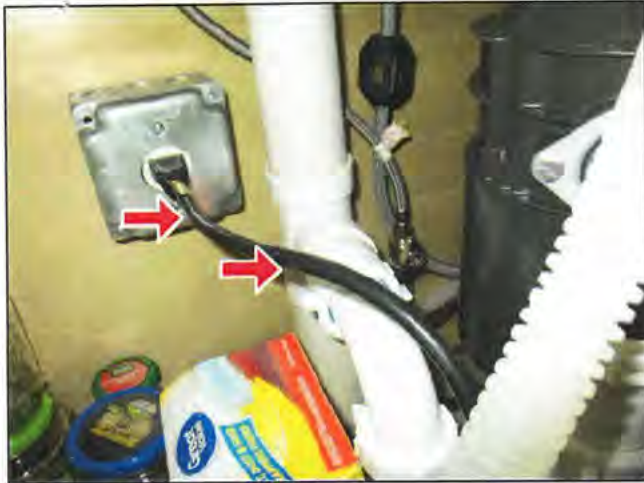
7.3 Item 1(Picture)

**7.3 (1)** Exposed wiring at the garbage disposer in the kitchen. Exposed wiring is considered unsafe until repaired. A qualified licensed electrical contractor should correct as needed.

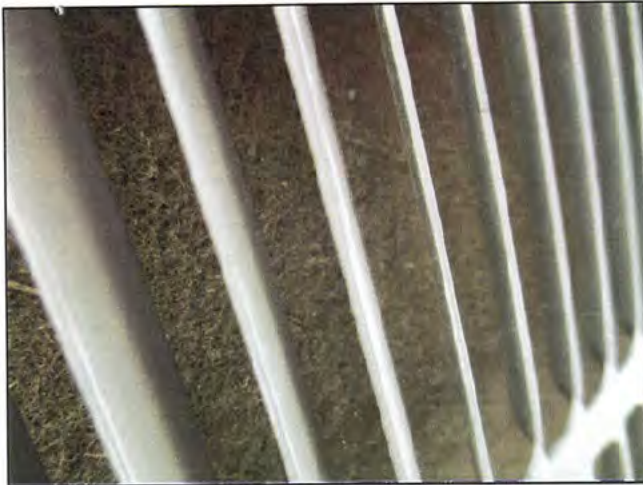
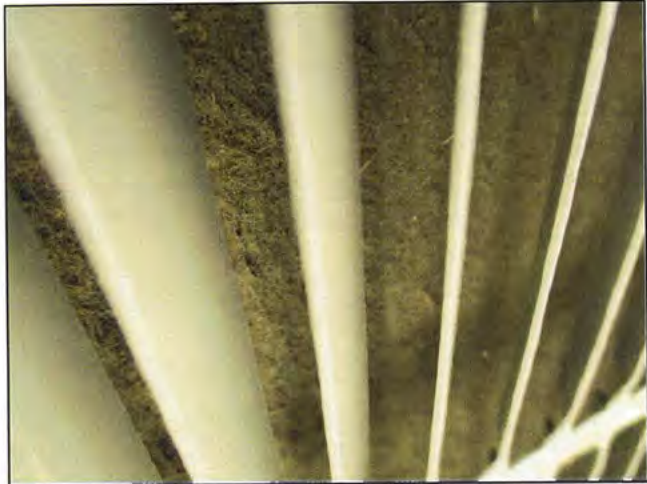
**8.8** The condenser A/C unit needs servicing.and electrical controls checked. This is a maintenance issue and should be repaired. A licensed HVAC contractor should service or repair unit.

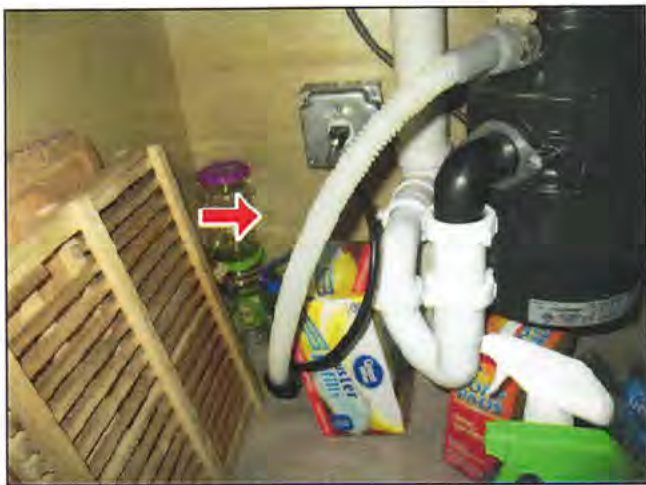
10.0 Item 1(Picture)

10.0 The dishwasher did not perform a loop to create a trap under sink. I recommend repair as necessary.

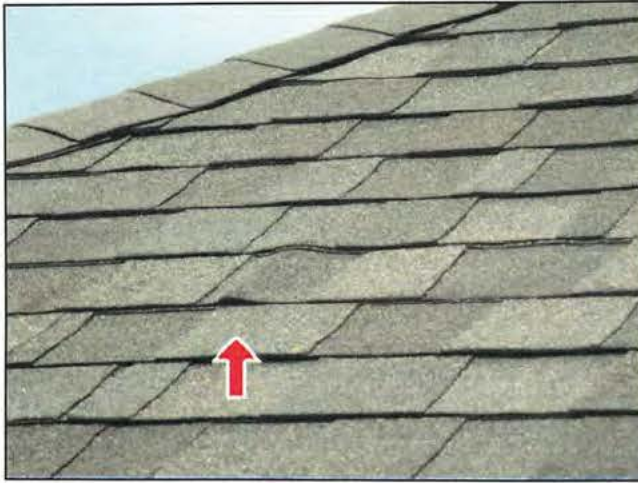
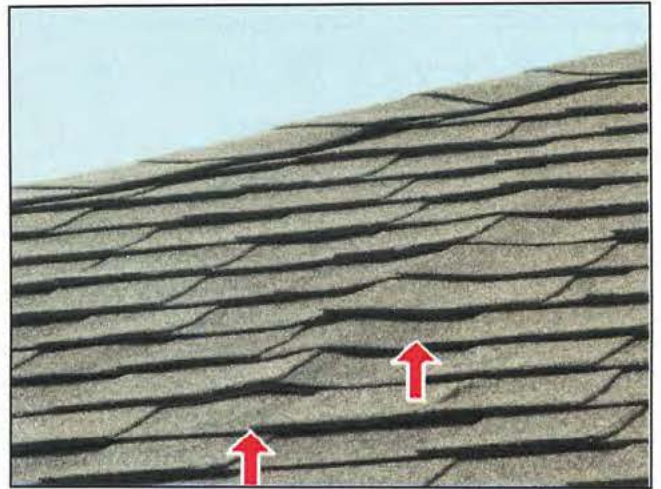
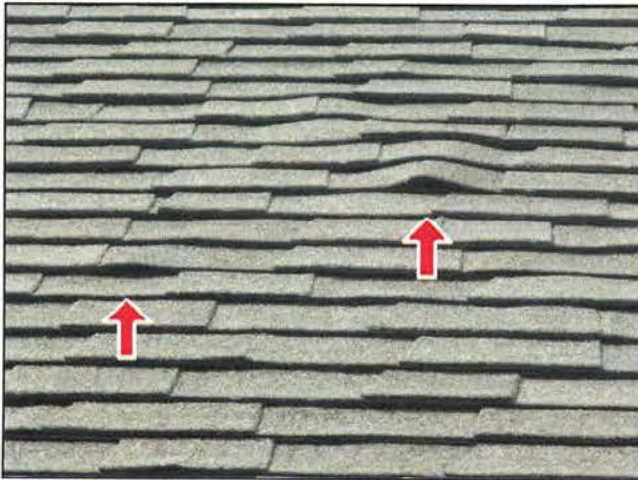
(3) The roof covering has raised shingles at areas of home. This does not appear adequate. It should be properly repaired or replaced. A qualified contractor should inspect and as needed.

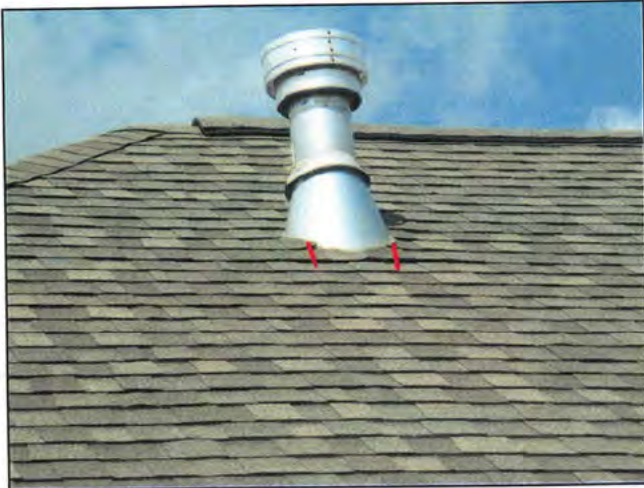
1.1 Item 1(Picture)

The flue pipe flashing needs roofing cut to allow water flow or rain water to get out. The . . . A qualified roofing contractor should inspect further and correct as needed.

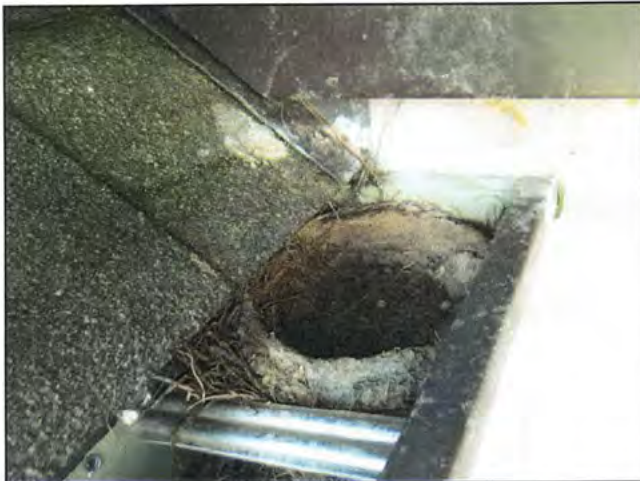
1.3 Item 1(Picture)

- (1) The gutters appear intact but due to the lack of recent rain, I am unable to determine if gutters leak at seams or spills water.
- (2)
- (3)
- (4)
- (5) The gutter has a birds nest at the front (left of main entry). . A qualified person should repair or as needed.

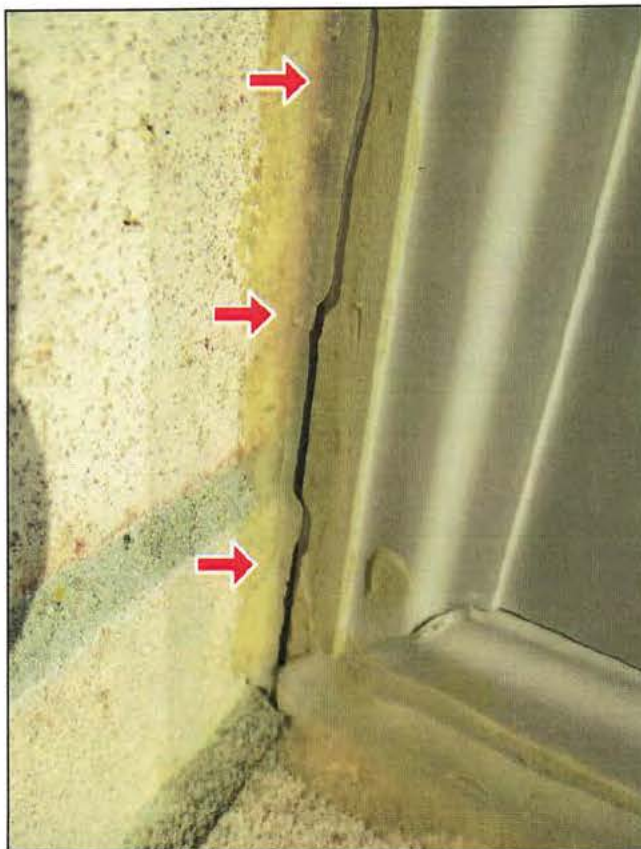
The window frame needs re-caulked at rear of home. Deterioration can allow water to enter behind siding or wall cavity and more damage could result. A qualified contractor should inspect and repair as needed.

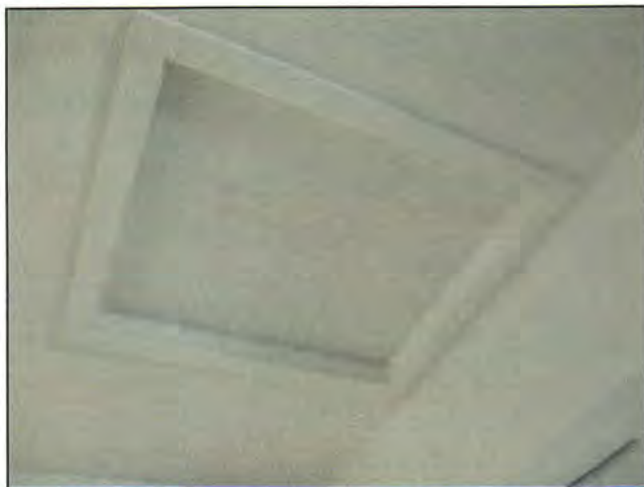
3.0 Item 1(Picture)

The wood attic accesses on the garage ceiling don't meet fire code. . .

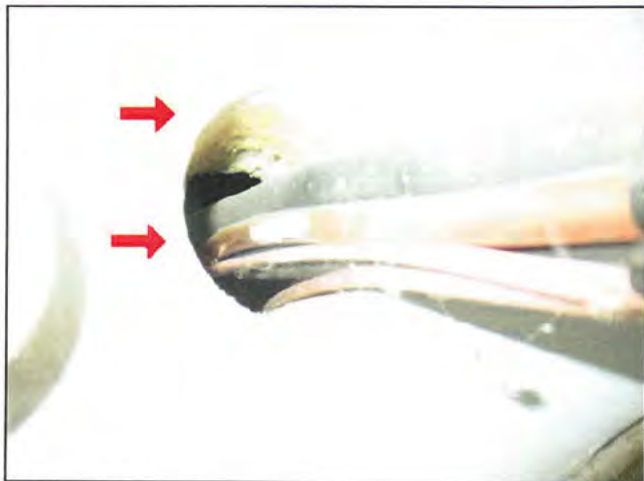
The firewall in garage holes need sealed up . This is considered unsafe until corrected. A qualified person should correct for safety.

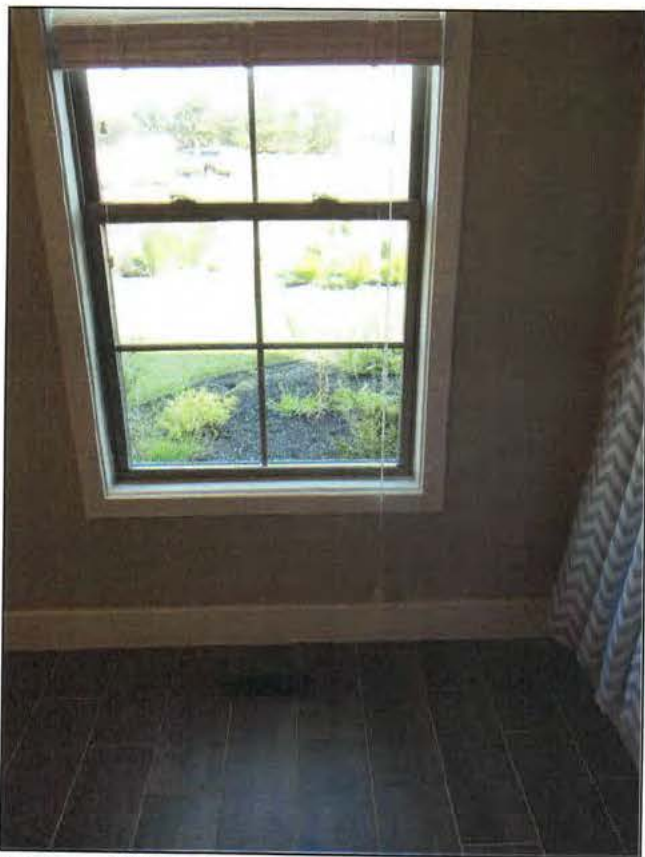
4.6 Item 1(Picture)

One window not tempered safety glass at the Guest bath. slip or fall out of tub/shower not safety glass. A qualified contractor should inspect and repair as needed.

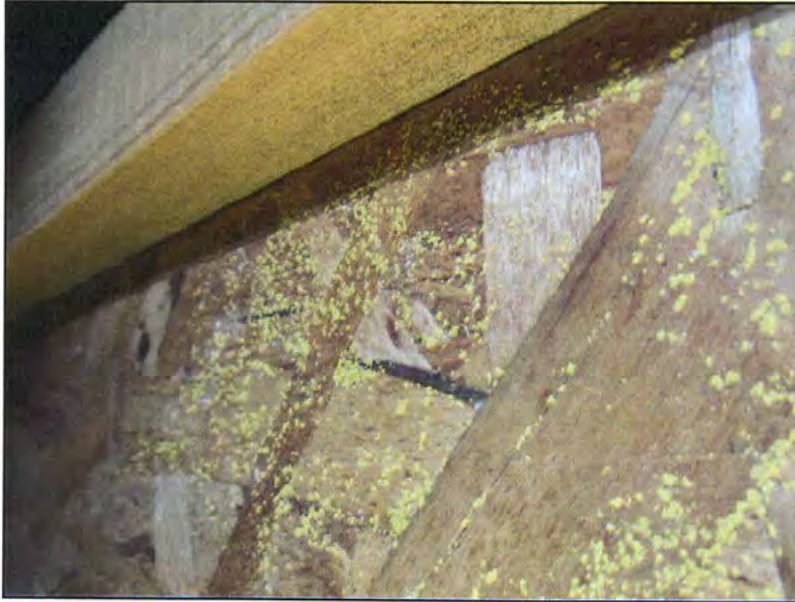
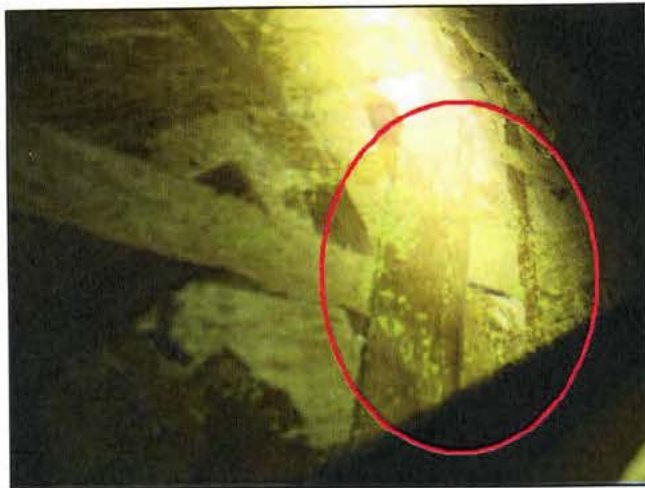
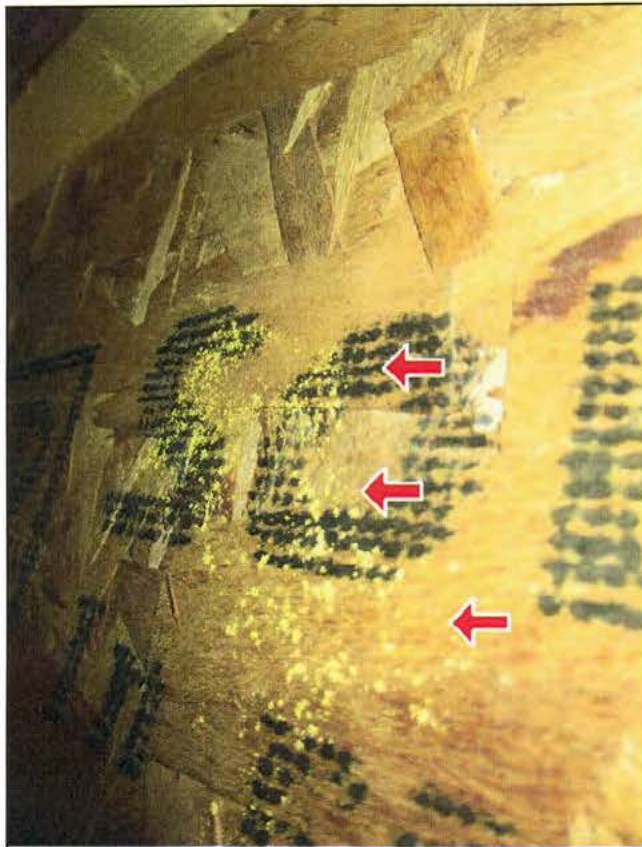
(1) Signs of fungi growth is present on the floor system in crawlspace in several areas. We did not inspect, test or determine if this growth is or is not a health hazard. The underlying cause is moisture. I recommend you contact a mold inspector or expert for investigation or correction if needed.

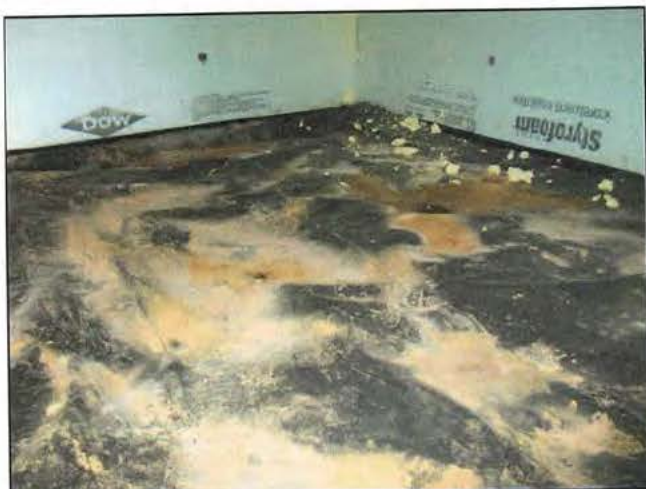
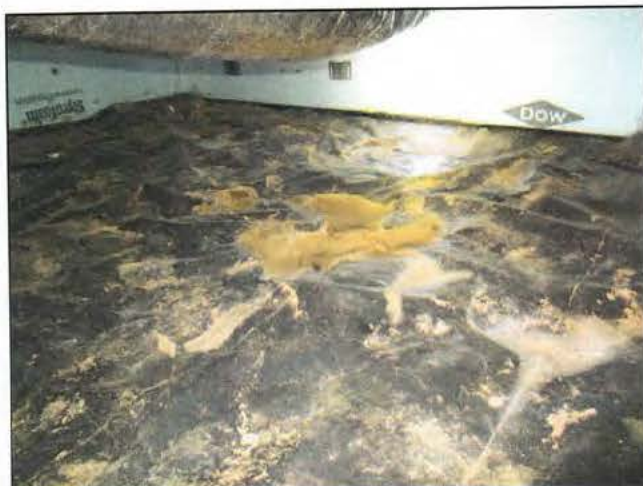
(2) Visible signs of water intrusion in the crawlspace are present from water stains on on plastic vapor barrier. I am unable to determine the extent of intrusion or how often it occurs. I recommend further investigation or correction by a qualified licensed contractor or water infiltration specialist.

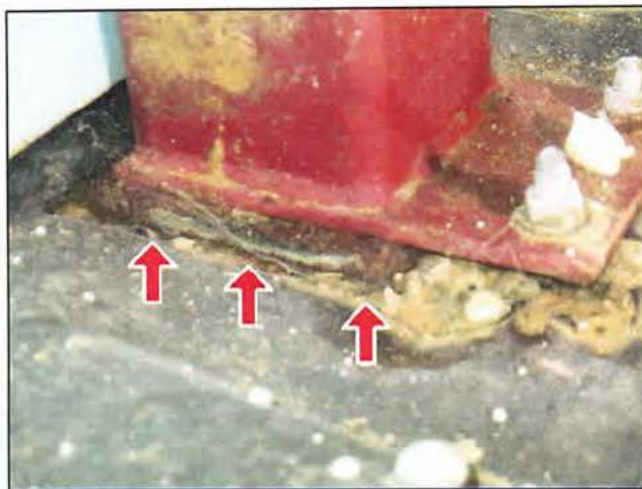
The support posts are deteriorated at the bottom of the posts in the crawlspace. the shims are rusting to fast either the posts are rusting lack of no separation from concrete or humidity.. A qualified licensed general contractor should inspect further and repair as needed.

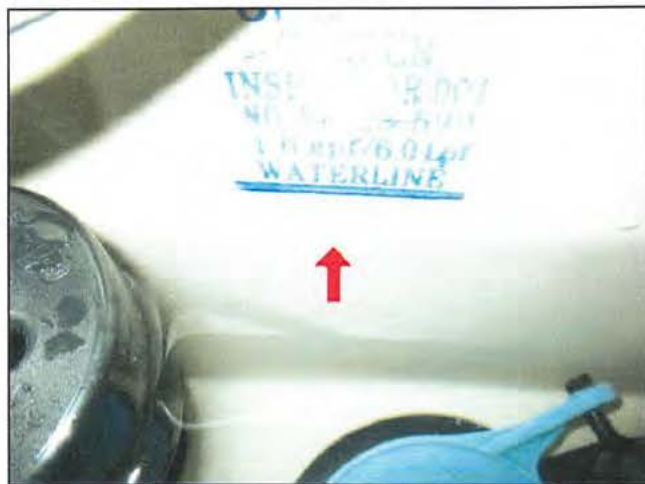
6.0 Item 1(Picture)

(1) The toilet fill line needs to be adjusted to ensure proper flushing at the hall bath. . A qualified licensed plumber should repair or correct as needed.

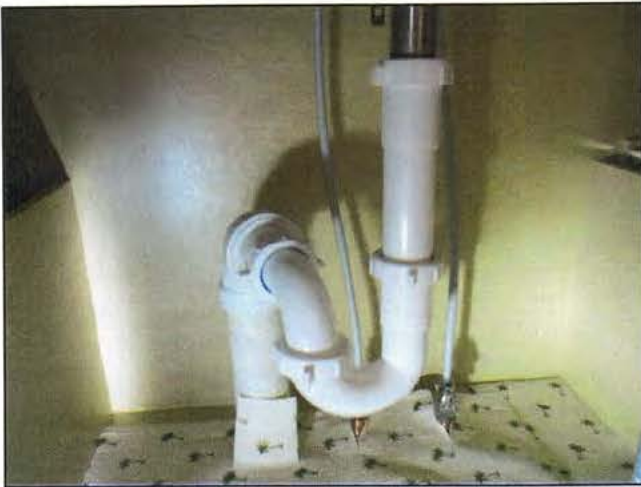
6.0 Item 2(Picture)

(2) The plumbing waste line is a S trap and needs upgrade to a P trap with an auto-vent at the Hall Bath sink and laundry room. This is not considered up to today's standard. A qualified licensed plumber should repair or correct as needed.

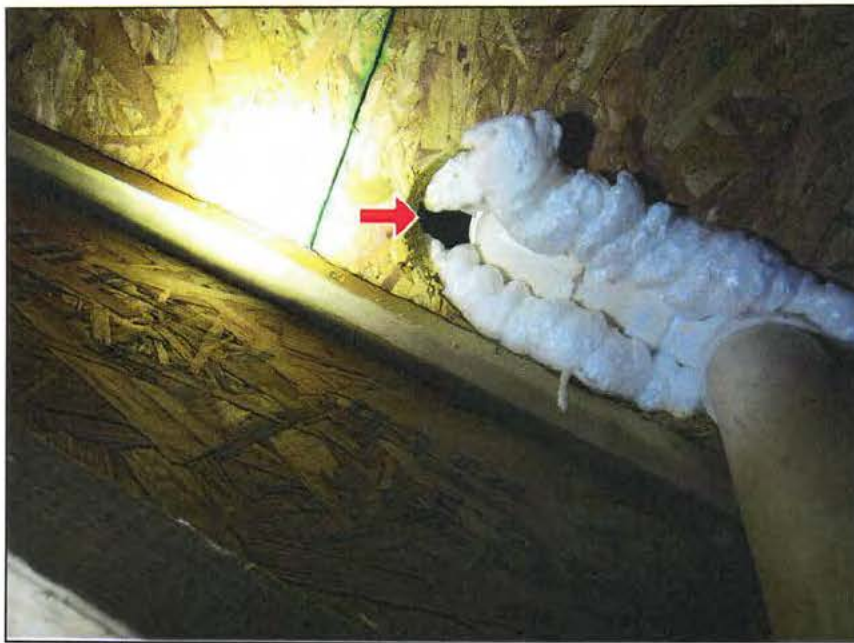
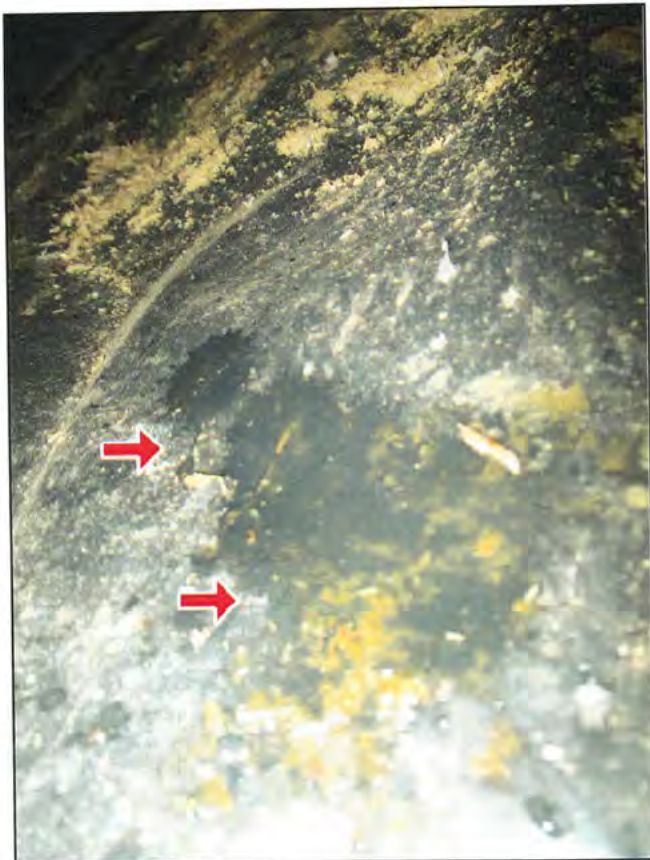
(3) The plumbing waste line not pitched correctly under the hall bath. . I recommend a licensed plumber inspect further and repair as necessary.

(4) The tub drain leaks under the hall bath. . A qualified licensed plumber should repair or correct as needed.

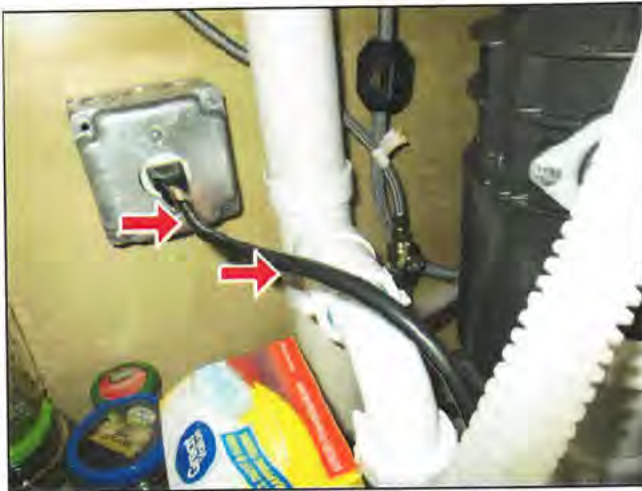
7.3 Item 1(Picture)

(1) Exposed wiring at the garbage disposer in the kitchen. Exposed wiring is considered unsafe until repaired. A qualified licensed electrical contractor should correct as needed.

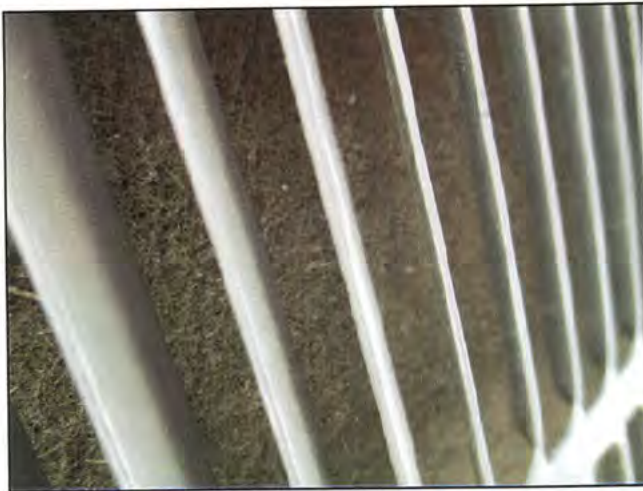
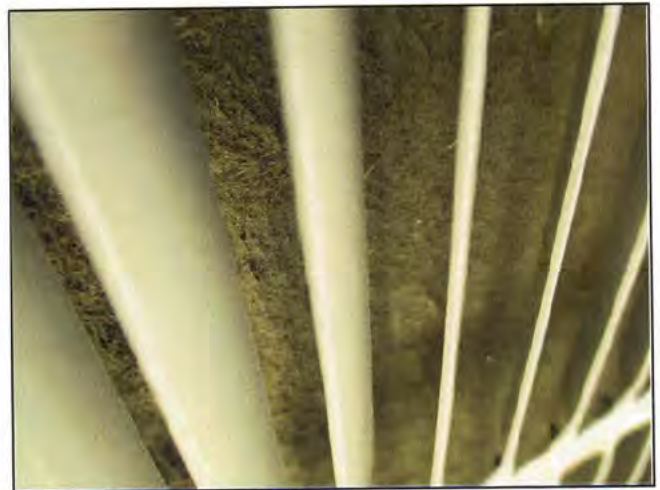
The condenser A/C unit needs servicing.and electrical controls checked. This is a maintenance issue and should be repaired. A licensed HVAC contractor should service or repair unit.

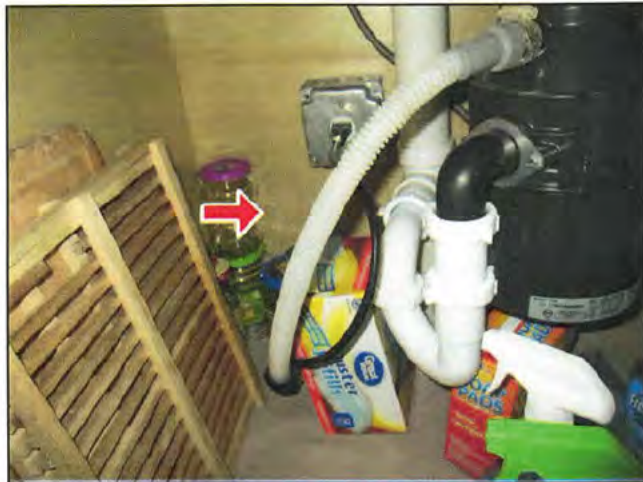
10.0 Item 1(Picture)

The dishwasher did not perform a loop to create a trap under sink. I recommend repair as necessary.
